SITE INVESTIGATION/REMEDIAL ACTION REPORT

BARRY BRONZE BEARING COMPANY, INC.

Block 604, Lot 1
2204 South 7th Street
Camden, Camden County, New Jersey

TTI Project No. 99-408

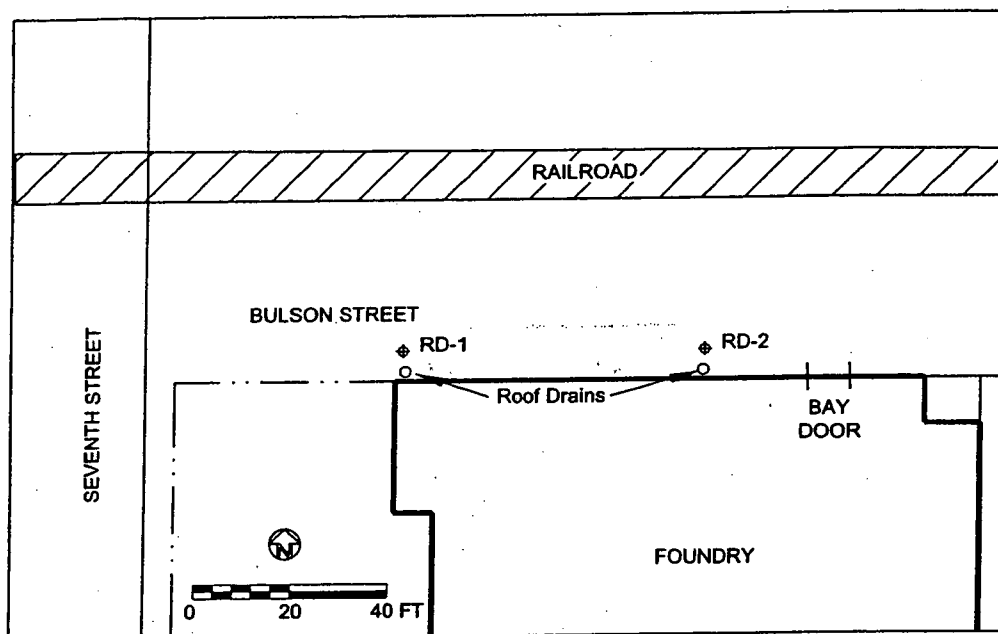
FIGURE 3.0:

The two (2) roof drains located along Bulson Street discharge to surficial soils. On August 12, 1999, TTI collected two (2) surface soil samples (RD-1 and RD-2) at the discharge point of the roof drains located along Bulson Street. The soil samples were collected at a depth of zero (0) to six (6) inches below grade. Both soil samples were submitted for PP Metals and Hexavalent Chromium analysis. A sample location diagram is enclosed as Figure 3.0 and Table 1.0 below summarizes the field screening/analytical results.

The analytical results for the two (2) samples collected revealed elevated concentrations of Copper and Lead above the NJDEP Most Stringent Soil Cleanup Criteria.

TTI will provide a Remedial Action Workplan for this area of concern once the meetings with the property owners have taken place.

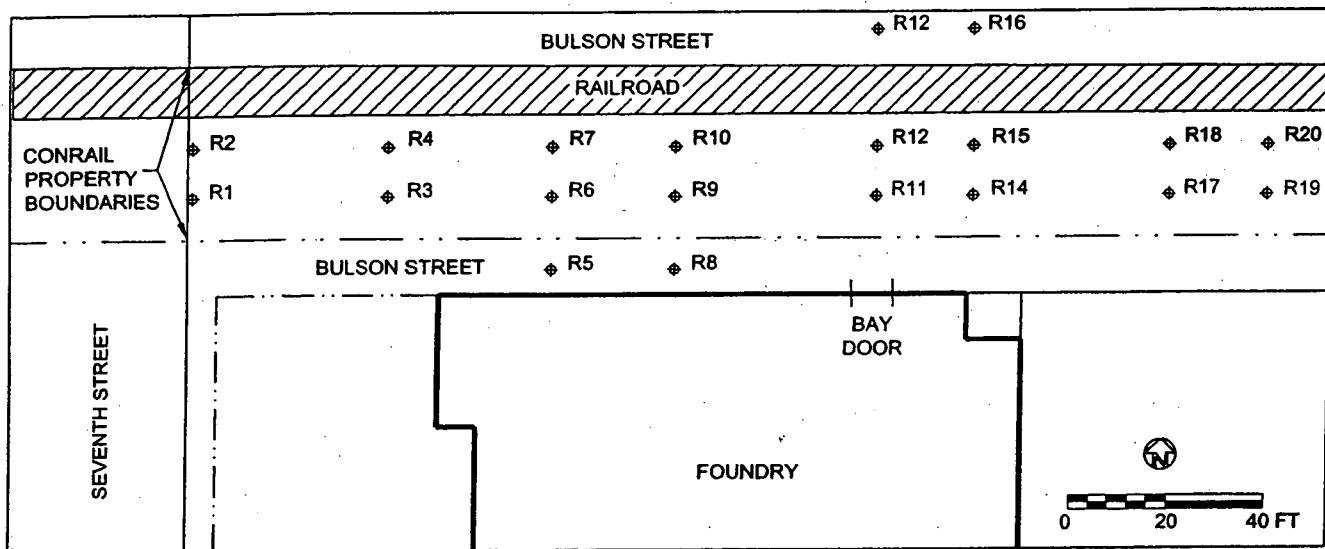
FIGURE 4.0:

The PA identified that used foundry sand was utilized for filling in depressions along Bulson Street and the Conrail railroad line. Bulson Street is an unimproved Camden City roadway positioned parallel and adjacent to the railroad line. In order to determine if the area along Bulson Street has been impacted from foundry sand, TTI conducted a surface and subsurface soil sampling program. TTI placed a total of 20 boreholes along the Bulson Street area. A total of 24 soil samples were submitted for Copper and Lead analysis. Copper and Lead were chosen because these compounds are the primary contaminants of concern and will provide a reliable indication of the distribution of the foundry sand. The analytical results are summarized in Table 2.0 and a sample location diagram is included in Figure 4.0.

The analytical results revealed impacted surface soils at all sample locations. Samples collected at one and one-half (1.5) to two (2) feet and two and one-half (2.5) to three (3) feet did not reveal any concentrations above MSCC which indicates that the impact is limited to the immediate surface.

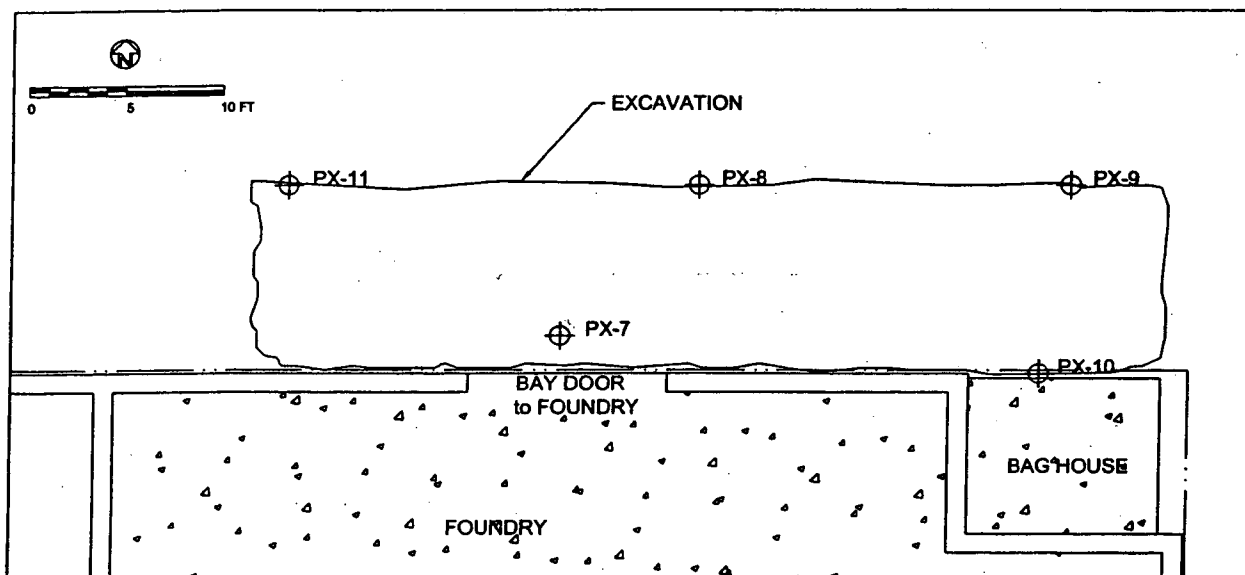
FIGURE 5.0:

The post excavation soil samples were submitted for Copper, Nickel, Lead, Antimony, Zinc, Hexavalent Chromium and TPH analysis. The analytical results are summarized in Table 3.0 and the sample locations are depicted in Figure 5.0.

The analytical results revealed levels of Copper and Lead in excess of the NJDEP MSCC.

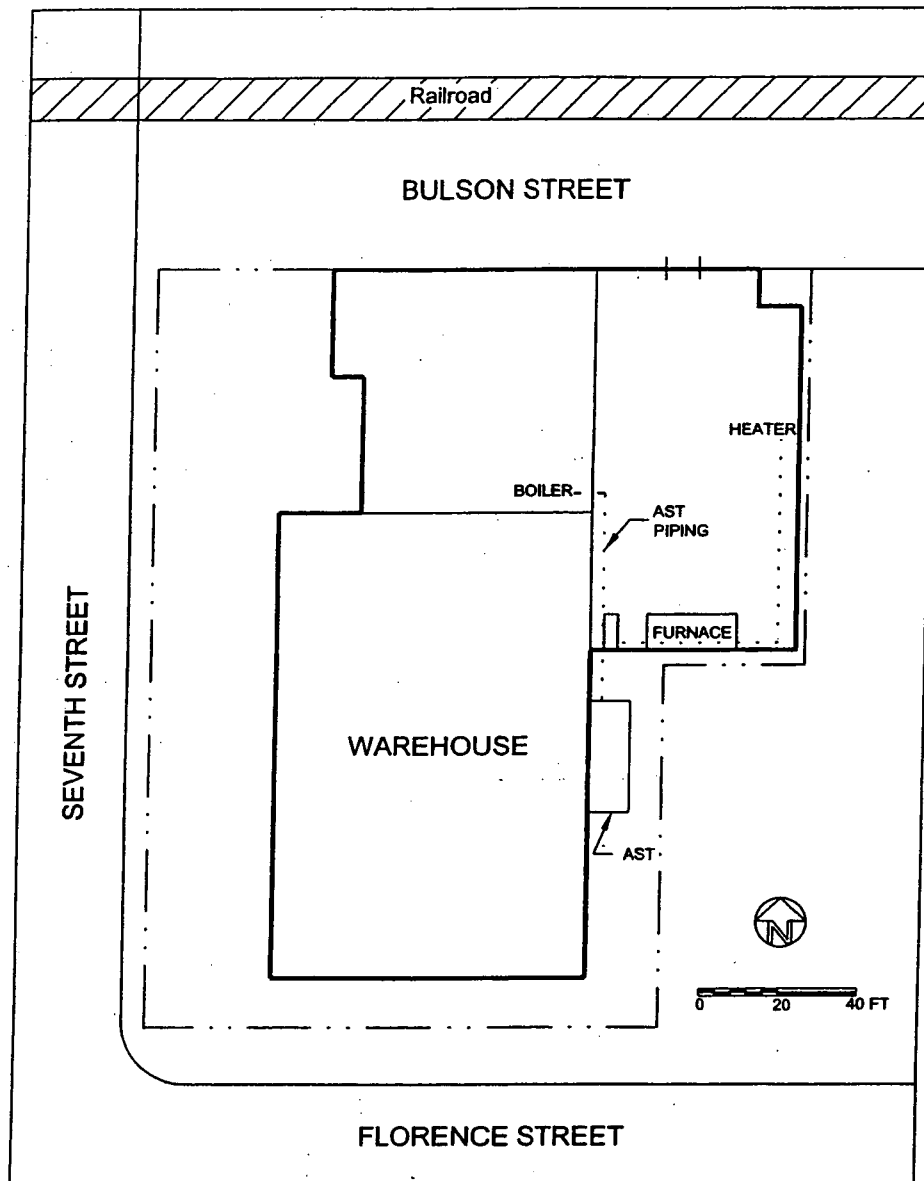
FIGURE 6.0:

The NJDEP site inspection letter indicated that a diagram and description of the AST piping system was required to determine if there is any evidence of staining and/or leaks associated with the system. A pipe line diagram is enclosed as Figure 6.0. All piping associated with the AST is located aboveground and no evidence of any leaks was observed. A valve located in the corner of the foundry was utilized to obtain fuel for igniting the furnace. This area was observed to contain visual staining of the wall and sand in this area and was addressed during the furnace pit remediation (see Section 5.9).

The inspection of the AST piping system revealed that the system was intact and no evidence of any leaks was observed. TTI recommends that no further investigation for this area of concern.

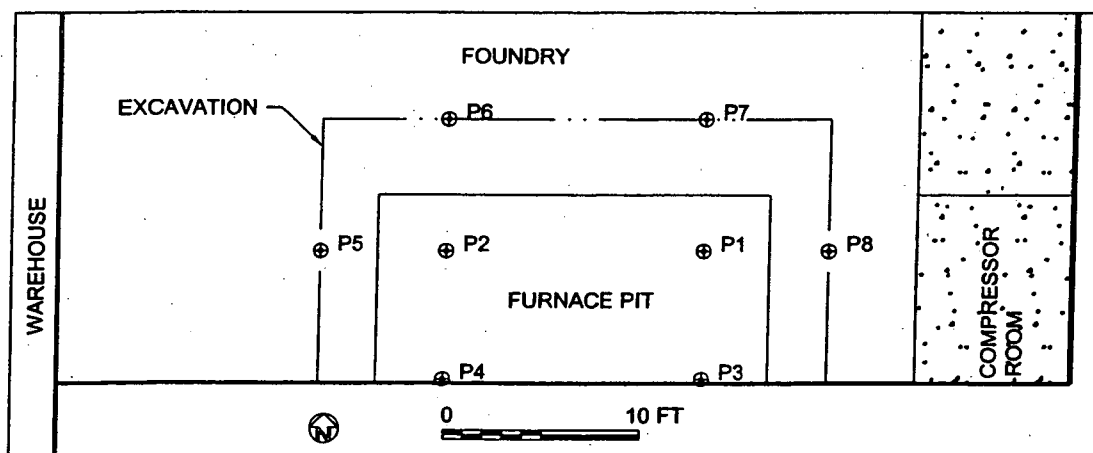
FIGURE 7.0:
SOIL SAMPLE LOCATION DIAGRAM -
FURNACE PIT

The original site investigation of the furnace pit revealed the presence of Petroleum Hydrocarbon, Lead, Copper, Zinc and Antimony impacted soils. The week of November 15, 1999, TTI personnel conducted a remediation of the impacted soil within the furnace pit. The remediation activities consisted of the removal of three (3) of the four (4) furnace walls and removal of piping/equipment. The fourth wall was left intact since this was a load bearing wall.

The analytical results revealed high concentrations of TPH remaining at the bottom and sidewalls of the excavation. In addition, one (1) of the samples, P-1, was submitted for VO+10 analysis and revealed concentrations of Total Xylene above the Most Stringent Cleanup Criteria.

TTI performed an initial remediation of the furnace pit that included the removal of three (3) of the four (4) furnace walls. Following the remediation of impacted soils, TTI collected post remediation soil samples that revealed concentrations of TPH to be reduced, but still in excess of the 10,000 mg/kg Remedial Action Criteria. TTI proposes to perform a vertical/horizontal delineation of the petroleum impacted soils via the placement of probeholes along the southern outside wall of the foundry. An attempt will be made to place probeholes within the foundry, but the dry, loosely packed sand present in this area may prevent the placement of these probeholes. Probeholes will be conducted utilizing direct push technology GeoProbe® or equivalent.

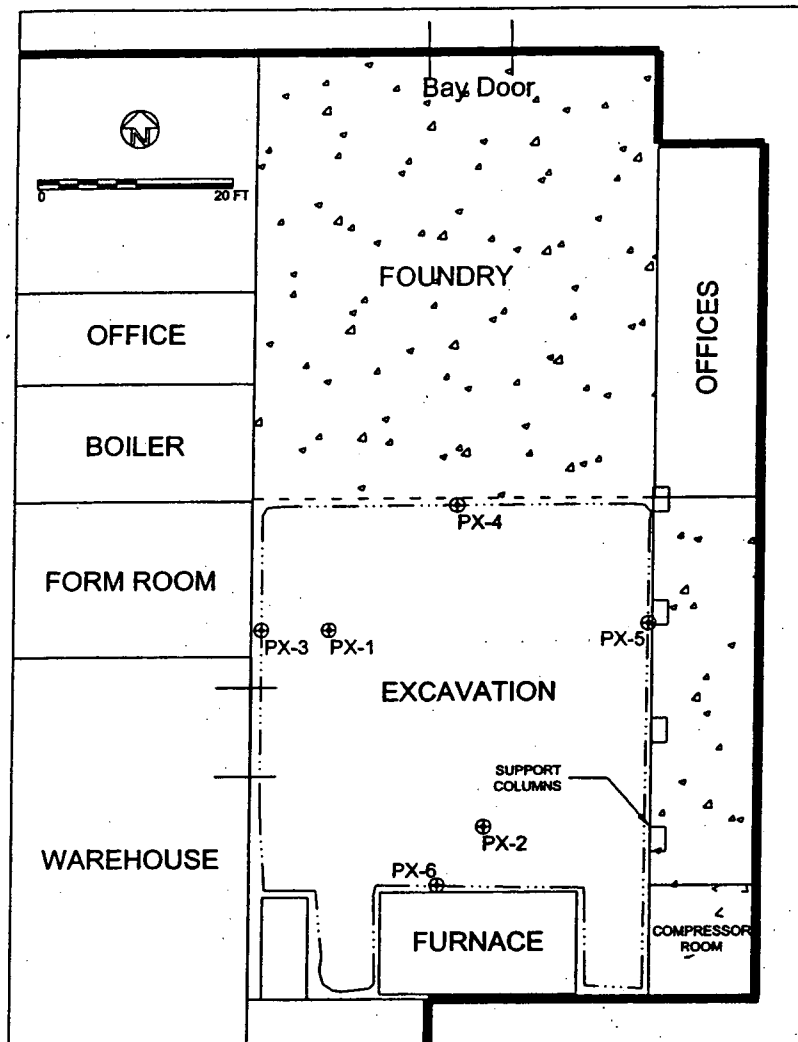
FIGURE 8.0:

Following the remediation of the contaminated soil in the earthen section of the foundry, TTI collected a total of six (6) post excavation soil samples on August 12, 1999. The six (6) post excavation soil samples consisted of two (2) bottom samples (PX-1 and PX-2) and four (4) sidewall samples (PX-3 thru PX-6). The sample locations are located in Figure 8.0 and the analytical results are summarized in Table 6.0.

The analytical results revealed elevated concentrations of metals in PX-1, PX-2, PX-5 and PX-6. In addition, PX-6 had a high concentration of TPH. This sample was collected along the furnace pit wall and this area was addressed during the soil remediation of the furnace pit (see Section 5.9). The post excavation soil samples which were collected in the area that PX-6 was collected are P-6 and P-7, see Figure 7.0 Furnace Pit.

The remedial action to date has reduced the concentrations of the contaminated soil within the foundry floor, however, concentrations of Copper at 11,700 ppm and Lead at 4,080 ppm remain. The proposed remedial action for the remaining contaminated soils is to treat the remaining soil and to place a cap on top of the treated soil. The material will be treated with the EnviroBlend® chemical technology followed by post treatment soil sample collection and analysis. The technology will be the same used in the remediation and disposal of sands from this area. This treatment will serve to stabilize the material with respect to the potential leachability of metals present within the sand. Upon confirmation of the soil treatment, this area will be covered to eliminate exposure of this material to future occupants. A four (4) to six (6) inch thick concrete floor shall be installed over this area which shall serve as a cap or barrier.

In summary, the EnviroBlend process will serve to immobilize the material with respect to its potential leachability and the concrete floor covering will eliminate direct contact by future building occupants. The building roof and concrete floor also protect this area from wind and rain that could transport the sands to other areas. A deed restriction shall be applied for in accordance with N.J.A.C. 7:26E and N.J.S.A. 58:10B-13. TTI will provide a Remedial Action Workplan for this area of concern along with the Exterior Used Sand Deposition Area.
